## **DENISE DUFFY & ASSOCIATES, INC.**

Date: March 29, 2024

**RE: Arborist Report for the City of Marina Del Monte Medians and Downtown Streetscape Project**

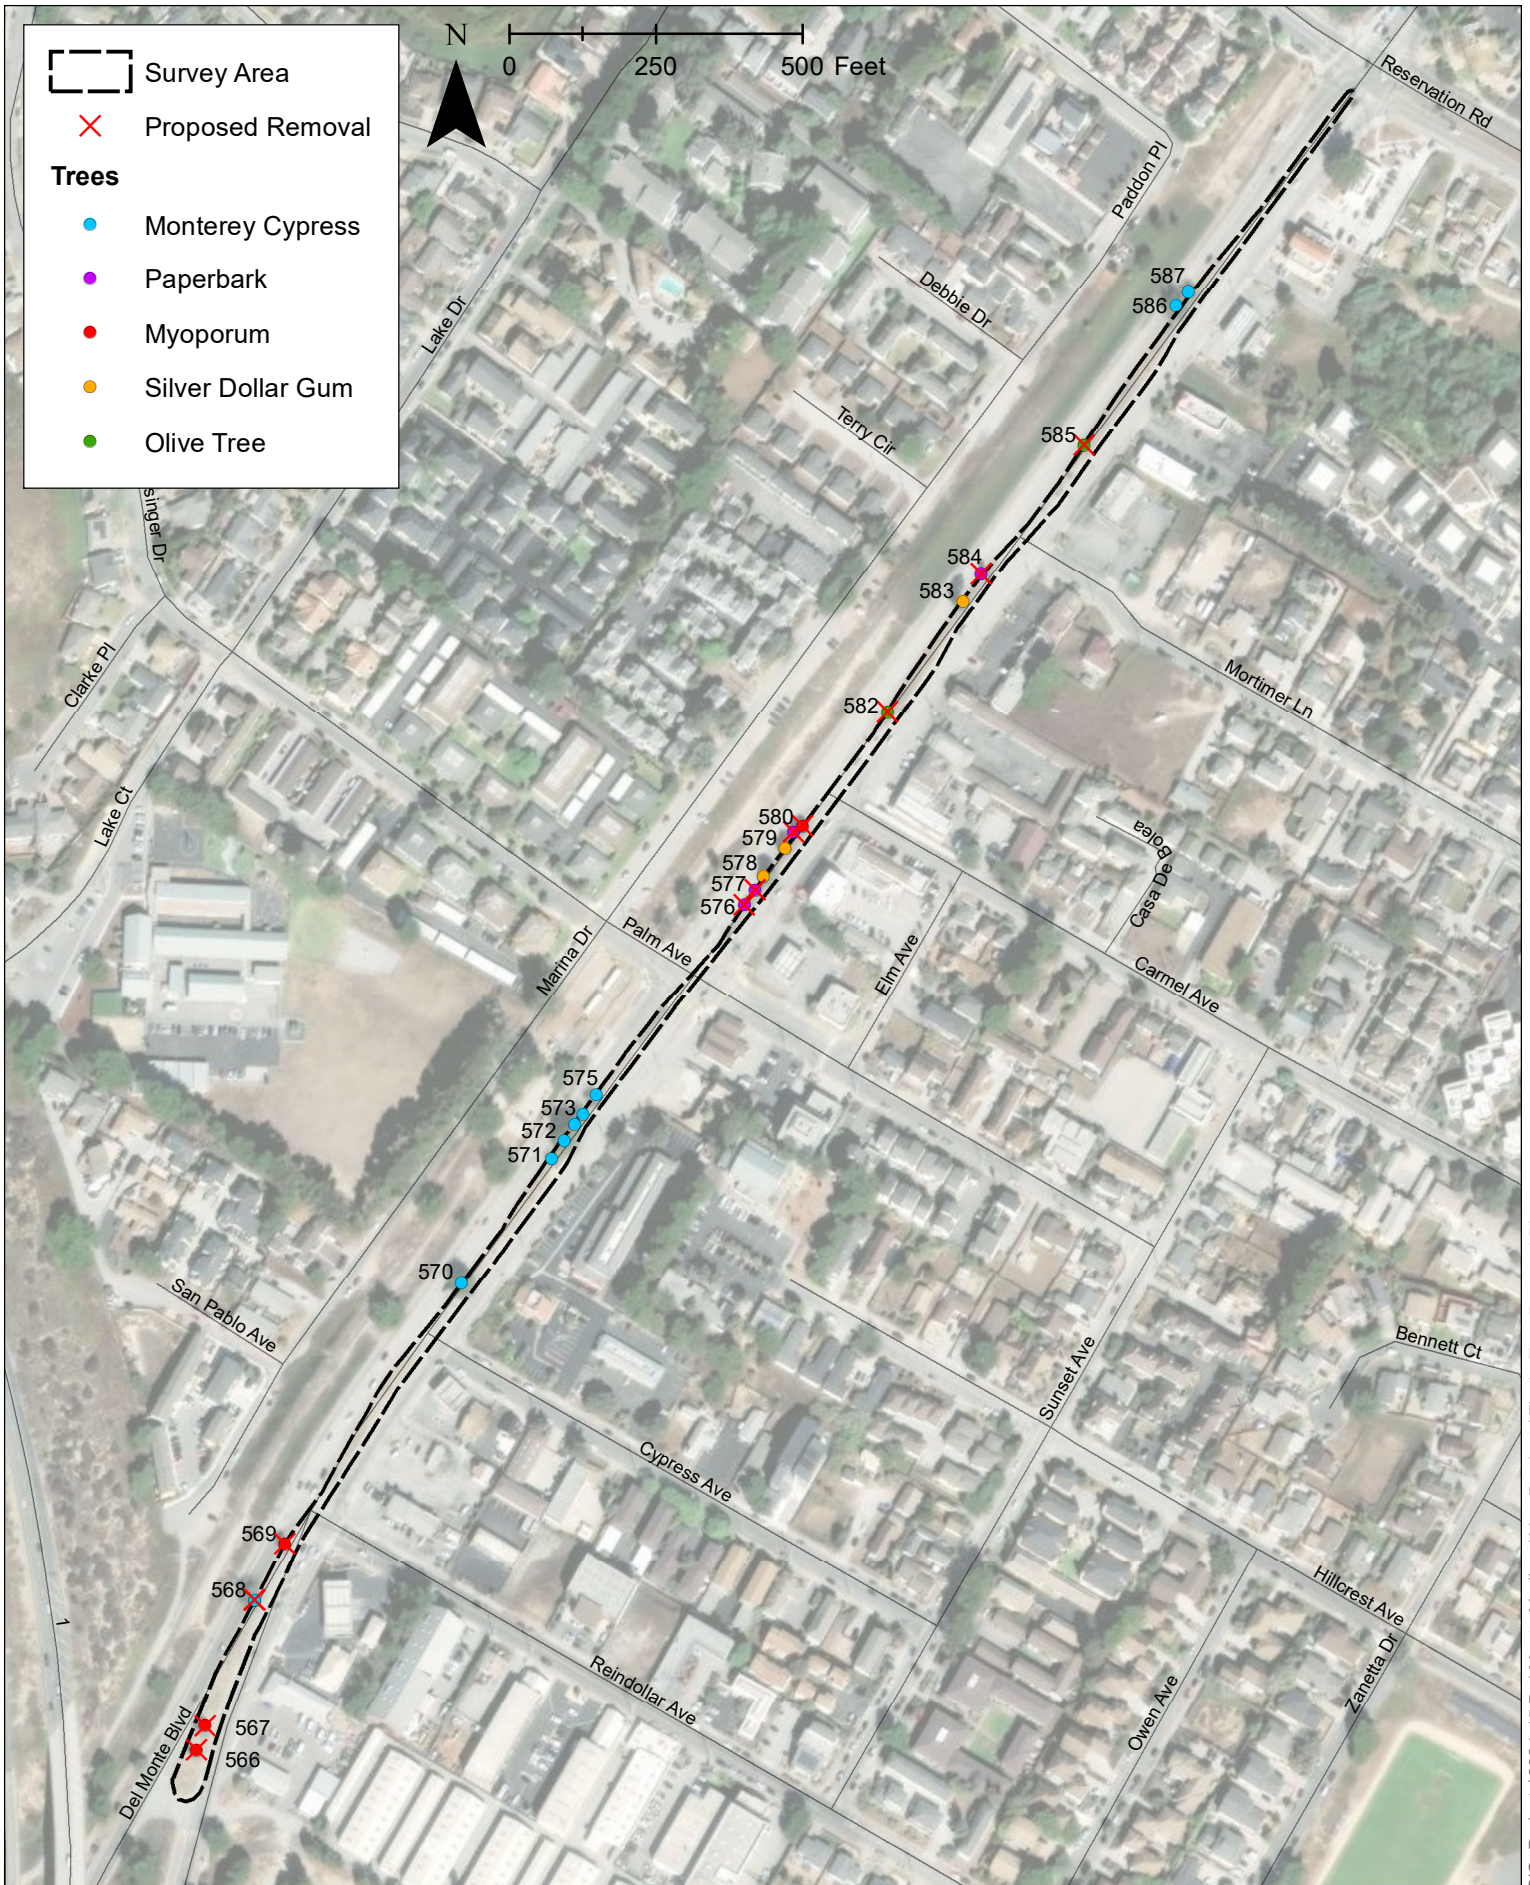
Figure  
**1**

DD&A inventoried 22 trees in the proposed project site, including nine (9) Monterey cypresses (*Hesperocyparis macrocarpa*), four (4) paperbarks (*Melaleuca quinquenervia*), four (4) myoporum (*Myoporum laetum*), three (3) silver dollar gums (*Eucalyptus polyanthemus*), and two (2) olive trees (*Olea europaea*) (**Figure 1; Appendix A**).

DD&A is recommending the removal of eleven trees, including one (1) Monterey cypress, four (4) paperbarks, four (4) myoporum, and two (2) olive trees (**Appendices A and B**). All trees proposed for removal are in poor condition. It is anticipated that these proposed removals would not survive construction of the project due to their declining health. It is also anticipated that the remaining trees in the project site can be avoided during construction.

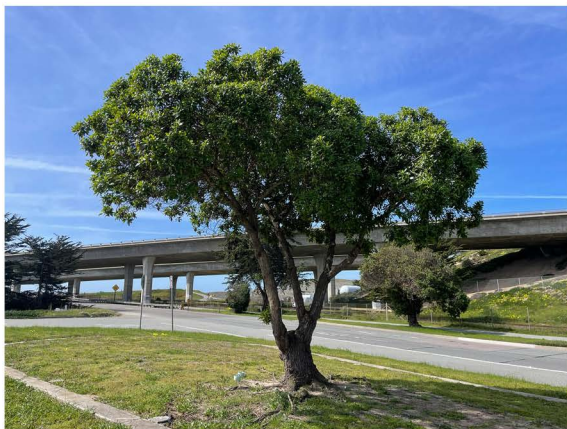
Tree #566

| Tag | Scientific Name | Common Name | Individual Stem<br>DBH (in) | | | | Total<br>DBH (in) | Dripline<br>(ft) | Health | Status | Tolerance to<br>Construction | Comments |
|---|---|---|---|---|---|---|---|---|---|---|---|---|
| 566 | <i>Myoporum laetum</i> | Myoporum | 6 | | | | 6 | 8 | Fair | Remove | Medium | Codominant stems, girdling roots |

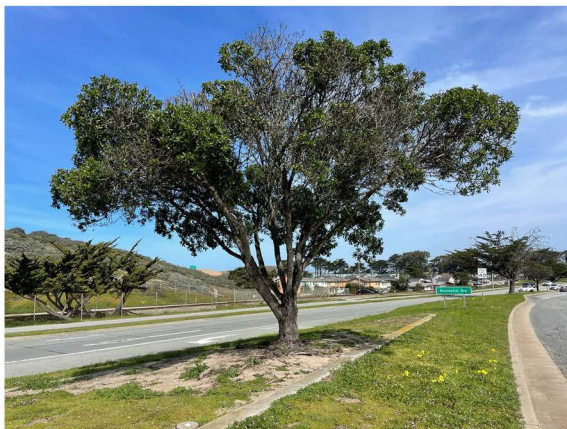
Tree #567

| Tag | Scientific Name | Common Name | Individual Stem<br>DBH (in) | | | | Total<br>DBH (in) | Dripline<br>(ft) | Health | Status | Tolerance to<br>Construction | Comments |
|---|---|---|---|---|---|---|---|---|---|---|---|---|
| 567 | <i>Myoporum laetum</i> | Myoporum | 18 | | | | 18 | 23 | Fair | Remove | Medium | Codominant stems, girdling roots |

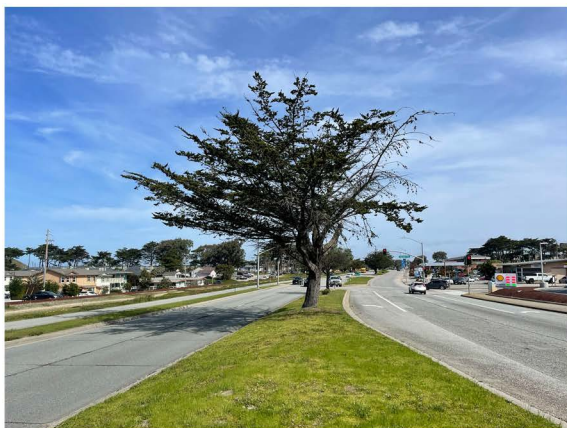
Tree #568

| Tag | Scientific Name | Common Name | Individual Stem<br>DBH (in) | | | | Total<br>DBH (in) | Dripline<br>(ft) | Health | Status | Tolerance to<br>Construction | Comments |
|---|---|---|---|---|---|---|---|---|---|---|---|---|
| 568 | <i>Hesperocyparis macrocarpa</i> | Monterey Cypress | 32 | | | | 32 | 40 | Poor | Remove | Low | Boring beetle, 1/3 canopy deadwood |

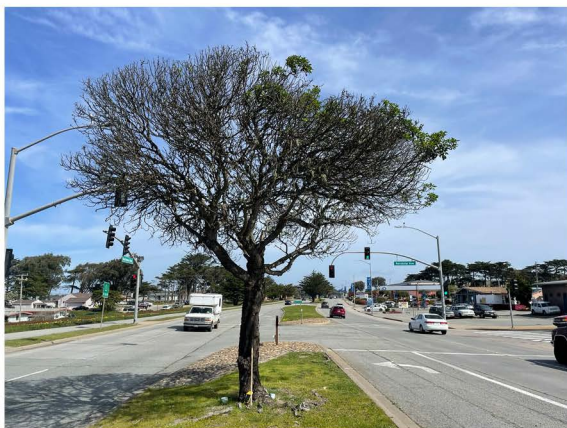
Tree #569

| Tag | Scientific Name | Common Name | Individual Stem<br>DBH (in) | | | | Total<br>DBH (in) | Dripline<br>(ft) | Health | Status | Tolerance to<br>Construction | Comments |
|---|---|---|---|---|---|---|---|---|---|---|---|---|
| 569 | <i>Myoporum laetum</i> | Myoporum | 17 | | | | 17 | 21 | Poor | Remove | Low | Girdling roots, excessive crown dieback |

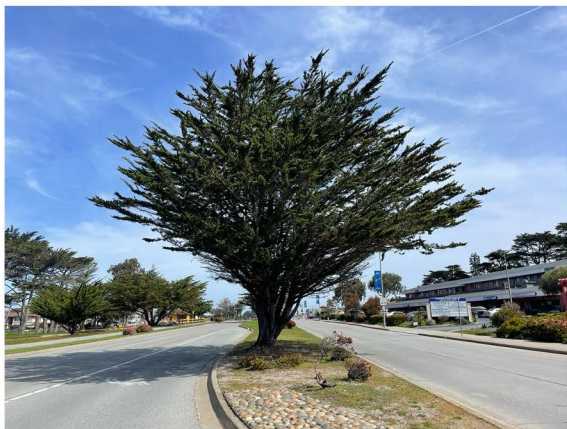
Tree #570

| Tag | Scientific Name | Common Name | Individual Stem<br>DBH (in) | | | | Total<br>DBH (in) | Dripline<br>(ft) | Health | Status | Tolerance to<br>Construction | Comments |
|---|---|---|---|---|---|---|---|---|---|---|---|---|
| 570 | <i>Hesperocyparis macrocarpa</i> | Monterey Cypress | 33 | | | | 33 | 41 | Good | Retain | Medium | Girdling roots |

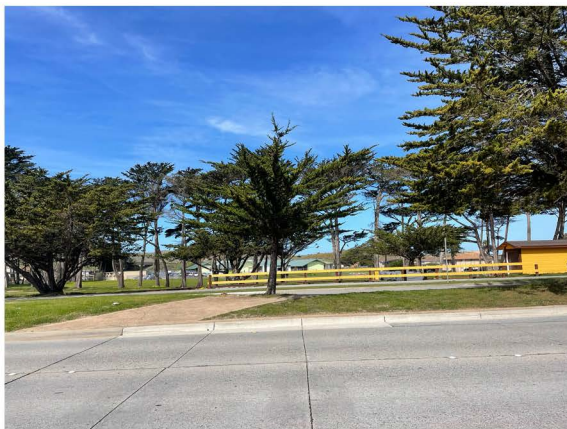
Tree #571

| Tag | Scientific Name | Common Name | Individual Stem<br>DBH (in) | | | | Total<br>DBH (in) | Dripline<br>(ft) | Health | Status | Tolerance to<br>Construction | Comments |
|---|---|---|---|---|---|---|---|---|---|---|---|---|
| 571 | <i>Hesperocyparis macrocarpa</i> | Monterey Cypress | 10 | | | | 10 | 13 | Fair | Retain | Medium | Excessive pitch, boring beetle |

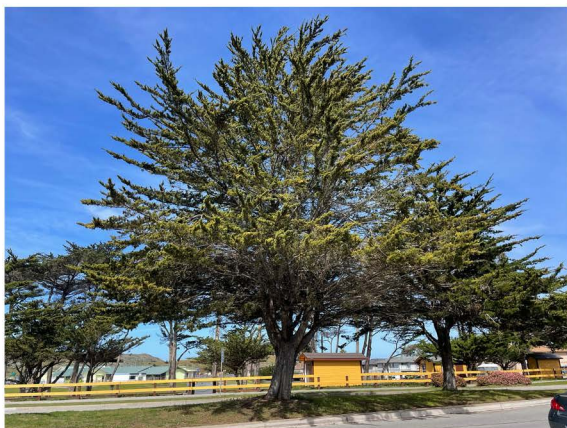
Tree #572

| Tag | Scientific Name | Common Name | Individual Stem<br>DBH (in) | | | | Total<br>DBH (in) | Dripline<br>(ft) | Health | Status | Tolerance to<br>Construction | Comments |
|---|---|---|---|---|---|---|---|---|---|---|---|---|
| 572 | <i>Hesperocyparis macrocarpa</i> | Monterey Cypress | 29 | | | | 29 | 36 | Good | Retain | Medium | Potential raptor nest |

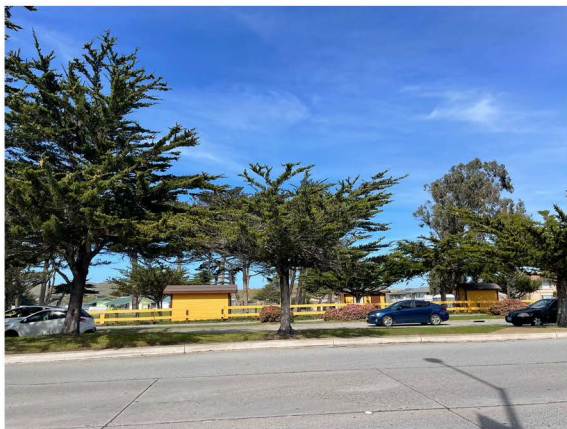
Tree #574

| Tag | Scientific Name | Common Name | Individual Stem<br>DBH (in) | | | | Total<br>DBH (in) | Dripline<br>(ft) | Health | Status | Tolerance to<br>Construction | Comments |
|---|---|---|---|---|---|---|---|---|---|---|---|---|
| 574 | <i>Hesperocyparis macrocarpa</i> | Monterey Cypress | 13 | | | | 13 | 16 | Fair | Retain | Medium | Crown dieback |

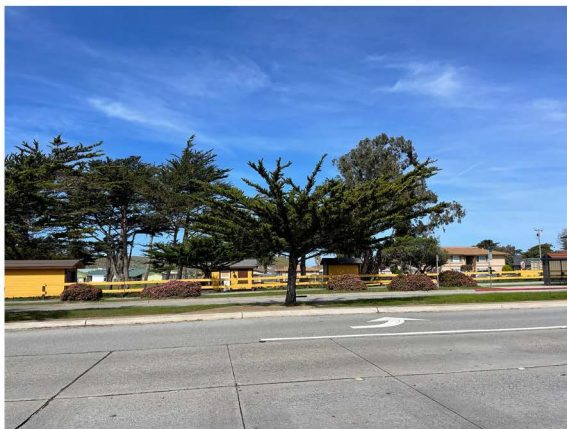
Tree #575

| Tag | Scientific Name | Common Name | Individual Stem<br>DBH (in) | | | | Total<br>DBH (in) | Dripline<br>(ft) | Health | Status | Tolerance to<br>Construction | Comments |
|---|---|---|---|---|---|---|---|---|---|---|---|---|
| 575 | <i>Hesperocyparis macrocarpa</i> | Monterey Cypress | 14 | | | | 14 | 18 | Fair | Retain | Medium | Crown dieback |

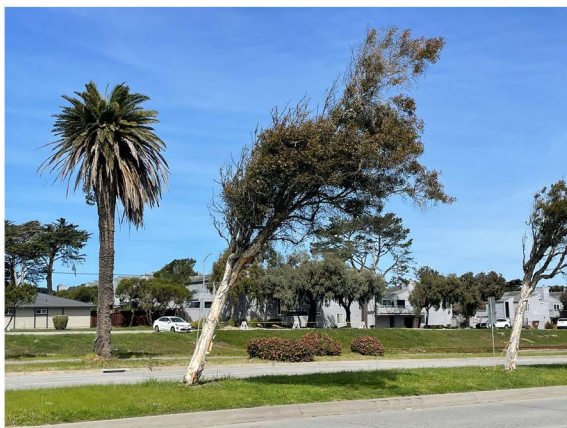
Tree #576

| Tag | Scientific Name | Common Name | Individual Stem<br>DBH (in) | | | | Total<br>DBH (in) | Dripline<br>(ft) | Health | Status | Tolerance to<br>Construction | Comments |
|---|---|---|---|---|---|---|---|---|---|---|---|---|
| 576 | <i>Melaleuca quinquenervia</i> | Paperbark | 12 | | | | 12 | 15 | Poor | Remove | Low | Severe lean, root collar damage, boring beetle, crown dieback |

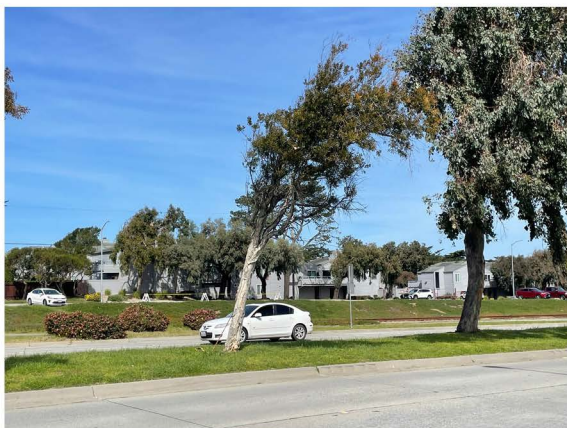
Tree #577

| Tag | Scientific Name | Common Name | Individual Stem<br>DBH (in) | | | | Total<br>DBH (in) | Dripline<br>(ft) | Health | Status | Tolerance to<br>Construction | Comments |
|---|---|---|---|---|---|---|---|---|---|---|---|---|
| 577 | <i>Melaleuca quinquenervia</i> | Paperbark | 12 | | | | 12 | 15 | Poor | Remove | Low | Severe lean, root collar damage, boring beetle, crown dieback |

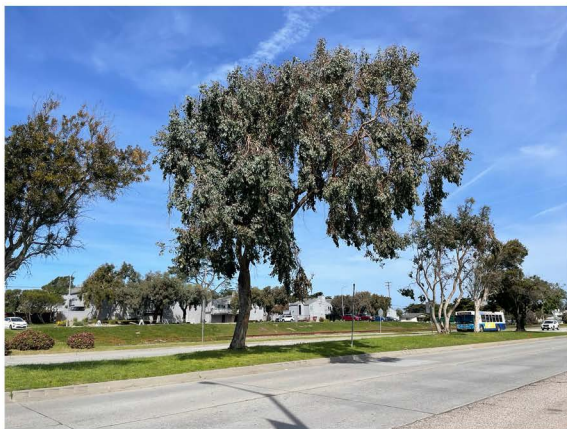
Tree #578

| Tag | Scientific Name | Common Name | Individual Stem<br>DBH (in) | | | | Total<br>DBH (in) | Dripline<br>(ft) | Health | Status | Tolerance to<br>Construction | Comments |
|---|---|---|---|---|---|---|---|---|---|---|---|---|
| 578 | <i>Eucalyptus polyanthemos</i> | Silver Dollar Gum | 23 | | | | 23 | 29 | Poor | Retain | Medium | Severe lean, root collar damage, boring beetle, crown dieback |

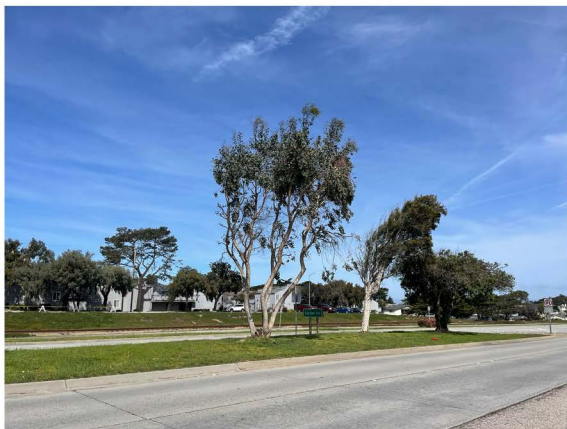
Tree #579

| Tag | Scientific Name | Common Name | Individual Stem<br>DBH (in) | | | | Total<br>DBH (in) | Dripline<br>(ft) | Health | Status | Tolerance to<br>Construction | Comments |
|---|---|---|---|---|---|---|---|---|---|---|---|---|
| 579 | <i>Eucalyptus polyanthemos</i> | Silver Dollar Gum | 11 | 9 | 9 | 7 | 14 | 18 | Fair | Retain | Medium | Codominant stems |

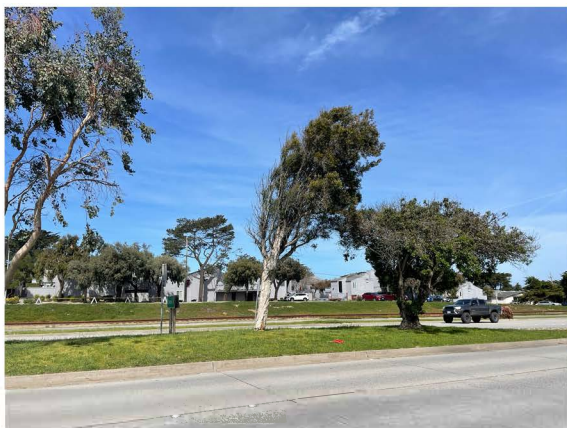
Tree #580

| Tag | Scientific Name | Common Name | Individual Stem<br>DBH (in) | | | | Total<br>DBH (in) | Dripline<br>(ft) | Health | Status | Tolerance to<br>Construction | Comments |
|---|---|---|---|---|---|---|---|---|---|---|---|---|
| 580 | <i>Melaleuca quinquenervia</i> | Paperbark | 17 | | | | 17 | 21 | Poor | Remove | Low | Severe lean, root collar damage, boring beetle, crown dieback |

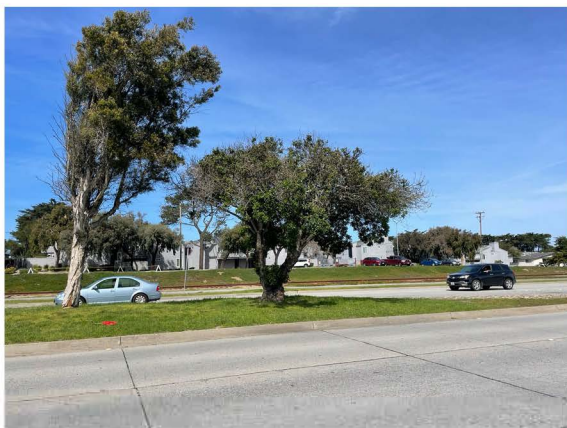
Tree #581

| Tag | Scientific Name | Common Name | Individual Stem<br>DBH (in) | | | | Total<br>DBH (in) | Dripline<br>(ft) | Health | Status | Tolerance to<br>Construction | Comments |
|---|---|---|---|---|---|---|---|---|---|---|---|---|
| 581 | <i>Myoporum laetum</i> | Myoporum | 17 | | | | 17 | 21 | Poor | Remove | Low | Girdling roots, codominant stems |

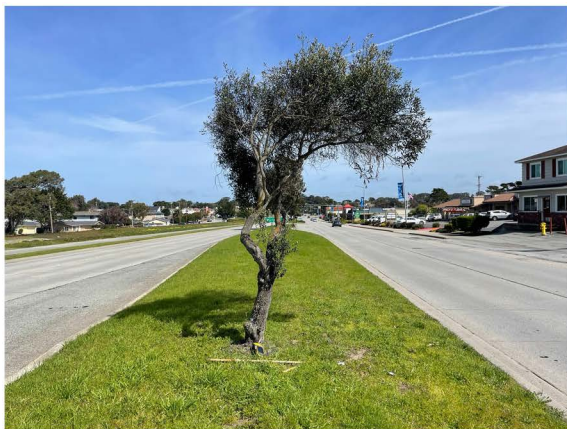
Tree #582

| Tag | Scientific Name | Common Name | Individual Stem<br>DBH (in) | | | | Total<br>DBH (in) | Dripline<br>(ft) | Health | Status | Tolerance to<br>Construction | Comments |
|---|---|---|---|---|---|---|---|---|---|---|---|---|
| 582 | <i>Olea europaea</i> | Olive Tree | 6 | | | | 6 | 8 | Poor | Remove | Low | Structural pruning would help tree health |

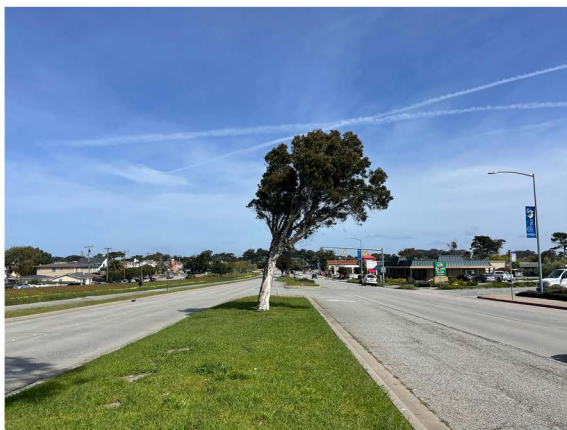
Tree #584

| Tag | Scientific Name | Common Name | Individual Stem<br>DBH (in) | | | | Total<br>DBH (in) | Dripline<br>(ft) | Health | Status | Tolerance to<br>Construction | Comments |
|---|---|---|---|---|---|---|---|---|---|---|---|---|
| 584 | <i>Melaleuca quinquenervia</i> | Paperbark | 19 | | | | 19 | 24 | Poor | Remove | Low | Severe lean, root collar damage, boring beetle, crown dieback |

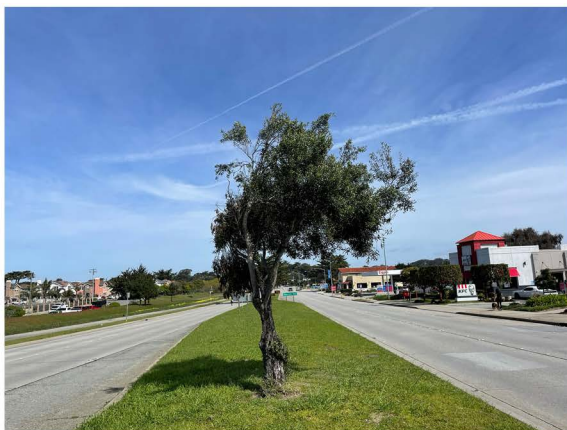
Tree #585

| Tag | Scientific Name | Common Name | Individual Stem<br>DBH (in) | | | | Total<br>DBH (in) | Dripline<br>(ft) | Health | Status | Tolerance to<br>Construction | Comments |
|---|---|---|---|---|---|---|---|---|---|---|---|---|
| 585 | <i>Olea europaea</i> | Olive Tree | 10 | | | | 10 | 13 | Poor | Remove | Low | Severe lean, root collar damage, poor structure, crown dieback |
